Here's the before picture of my (July 2020 built) 2021 2922KB Air Conditioner skirt in early 2021:

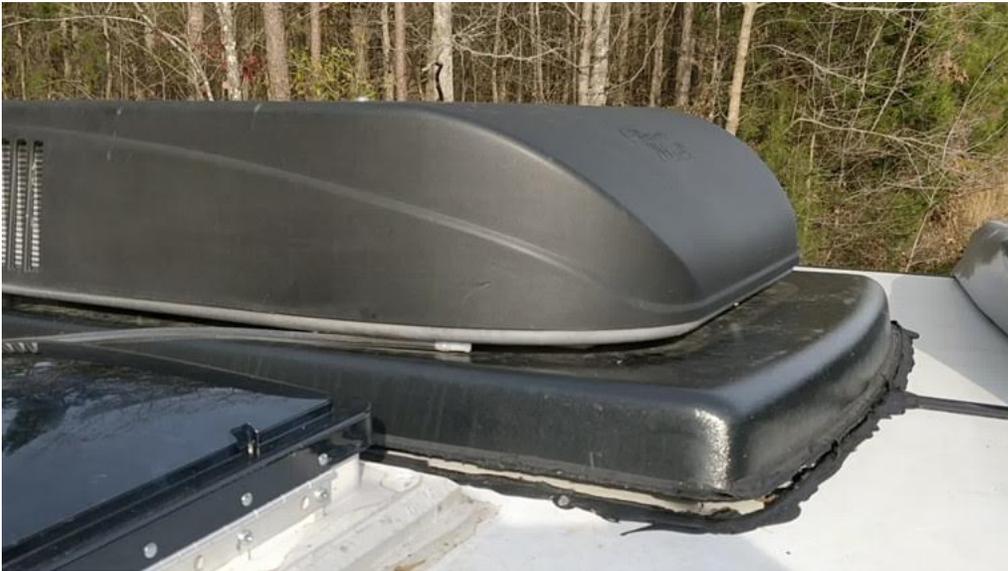
After getting the Air Conditioner lifted up to where I could examine the skirt, it was obvious that the adhesive/calk that was used underneath the skirt at the factory had never held the front of the A/C skirt in place.

The skirt was firmly attached at the rear and back, but completely loose up front.

In looking at the underside of the old A/C skirt and A/C riser (once the skirt was removed) I could see that the adhesive calk (TremPro RTV Silicone?) had never attached to the bottom side of the front. As soon as the A/C unit was placed on top of the skirt and it was exposed to sunlight the skirt warped which lead to the effort to span the 5/8" gap with Dicor Lap Sealant. Obviously that didn't work and lead to water getting under the A/C skirt and remaining long enough to cause significant rusting of the A/C riser nickel plated screws. (despite the fact that my TrailManor had been covered since October 2020.)

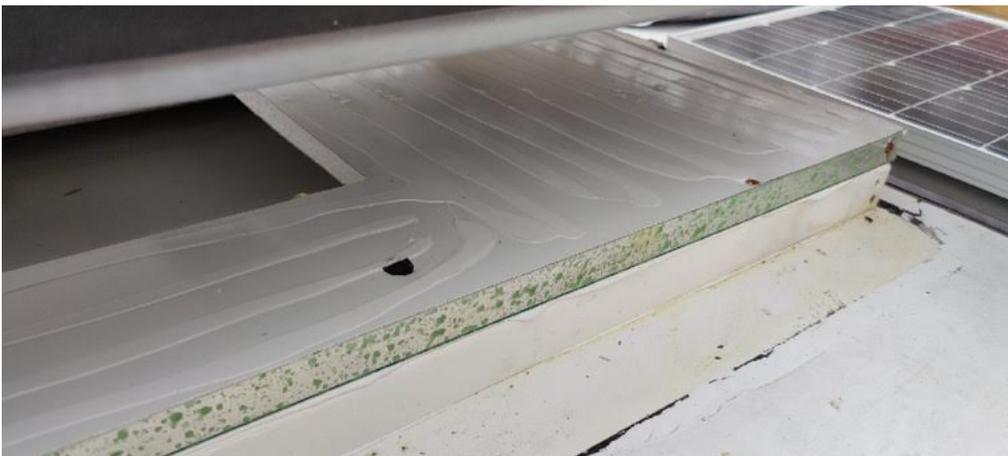
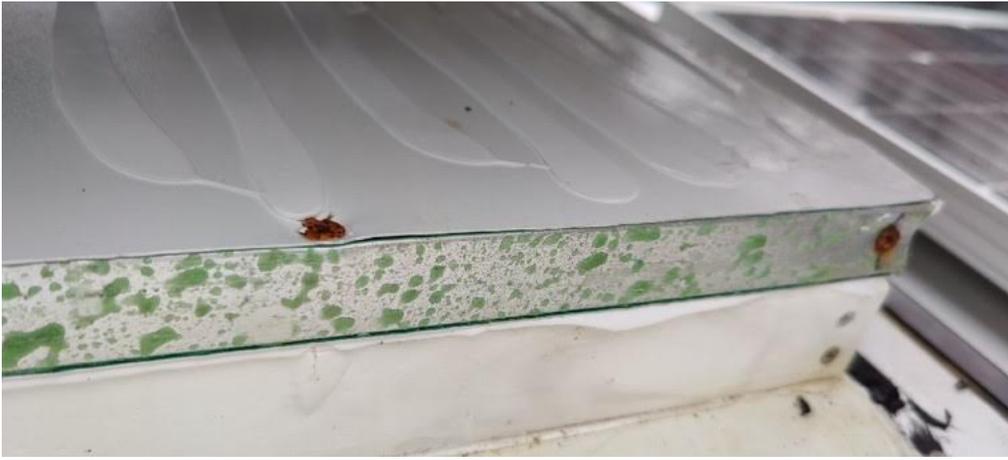
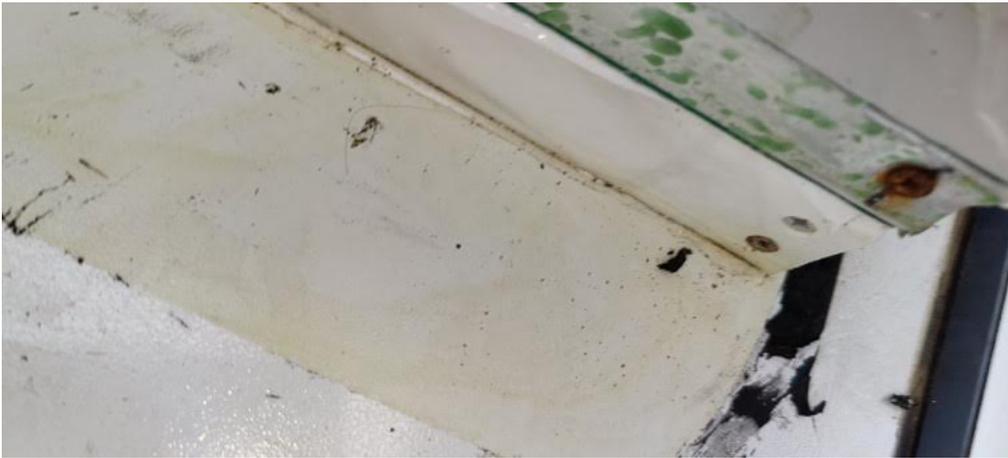
It only took about 90-120 days for the A/C riser screws to rust to the point that some of the screw heads were no longer viable.

Below are the during repair photos, you can see that the water and moisture which had been held under the A/C skirt had caused the nickel plated screws to rust pretty significantly:

After using rubbing alcohol to get up all of the old Dicor residue, I replaced all of those rusted nickel plated screws with stainless steel ones.

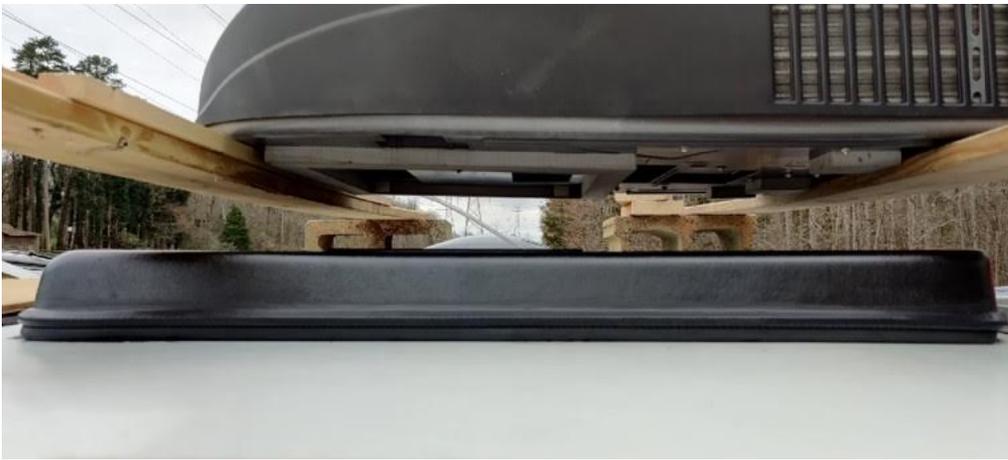
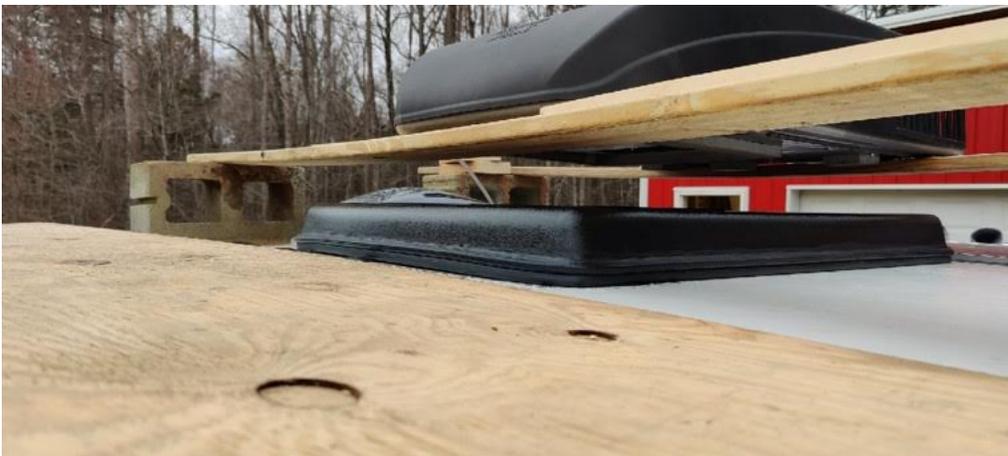
Below are placement photos before lowering the AC unit back down (**don't cringe- I have small plywood sheet blocks underneath the concrete blocks you see**):

I used a marine grade calk in the edge channel of that gasket which wrapped around the new A/C skirt and attached to it. That marine grade calk needed 24 hours drying time before forming a secure bond around the perimeter of the replacement A/C skirt.

I then placed the replacement A/C skirt on top of the TrailManor to confirm the footprint with the marine-grade hatch gasket applied. Once the footprint was confirmed, I removed the new A/C skirt and placed a fairly healthy bead of Dicor underneath and inside the area that the new hatch gasket would contact when it was set into place and also a very heavy coat along the back side of where the outer A/C skirt meets the inner A/C skirt. (that was due to the A/C skirt not having the same edge flair all the way around)

I also thoroughly coated the top of the inner A/C skirt with TremPro RTV Silicone before putting the new skirt in place and lowering the A/C down on top of the A/C skirt.

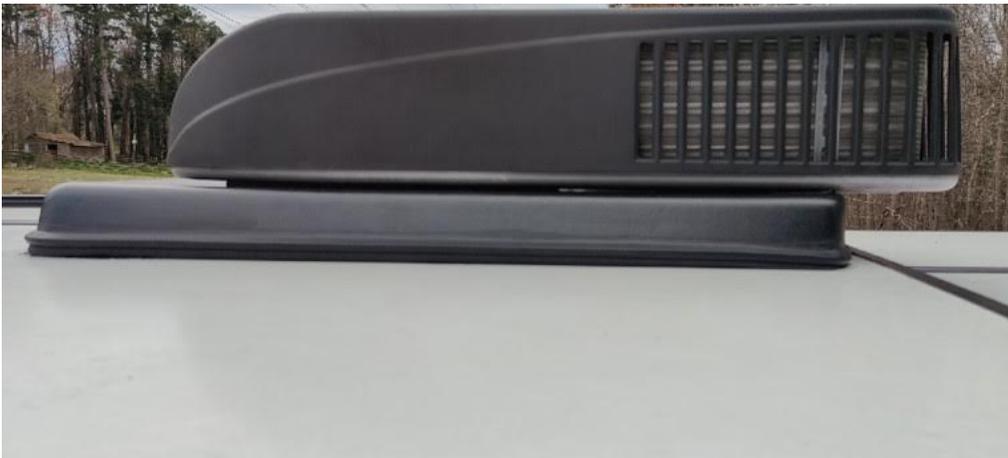
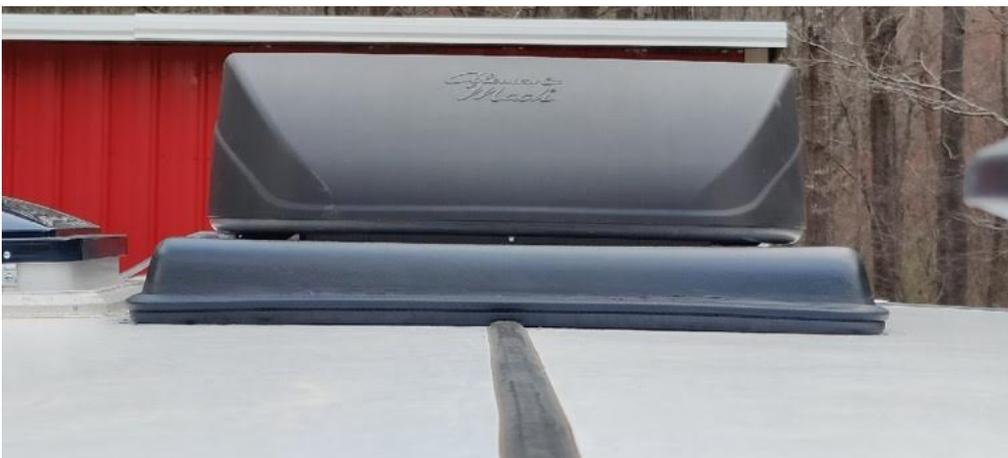
Below is the finished repair outside view with the A/C in place on top of the A/C skirt:

The application of the marine grade gasket resolves any potential issue of the A/C skirt warping and causing another gap. I also found, (after reassembling and testing the AC) that it also seems to significantly lessen the inside noise when running the Air Conditioner.
