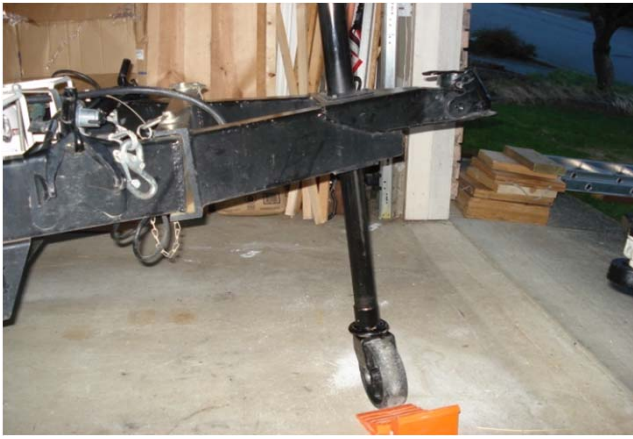
As tension in chains increases backing up steep driveway the bottom of the right side pin pushes against the relatively thin 1/4 inch plate causing it to bend out about 3/4 inch and creating a gap at the bottom of the swing hitch which was a concern for future failure.
